**Iowa Department of Natural Resources
Environmental Protection Commission**

Referrals to the Attorney General

LITIGATION REPORT

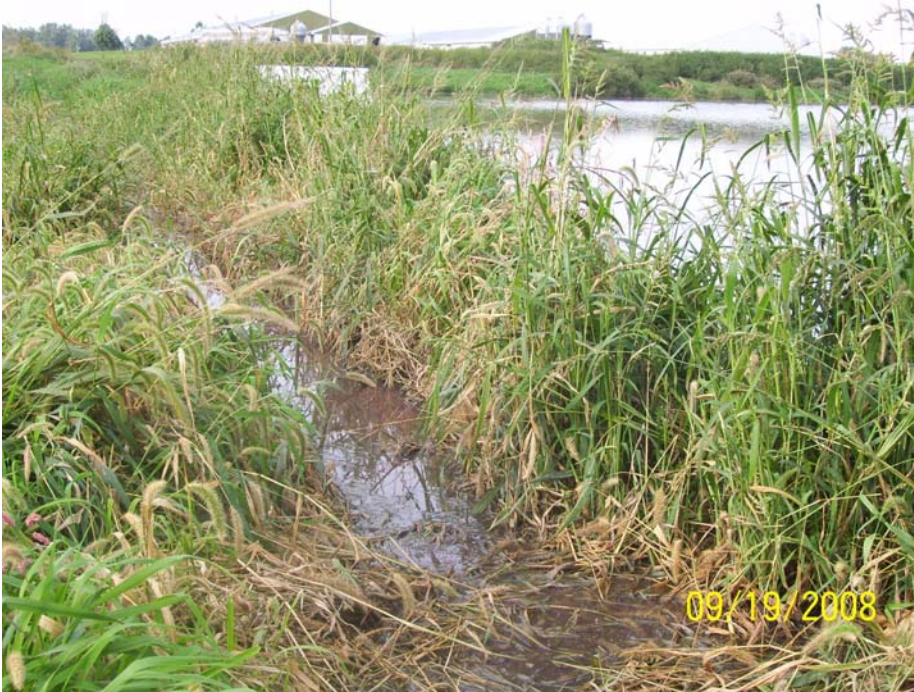
567 Iowa Administrative Code (IAC) 65.2(3) states that the minimum level of manure control for a confinement feeding operation shall be the retention of all manure produced in the confinement enclosures between periods of manure application. In no case shall manure from a confinement feeding operation be discharged directly into a water of the state or into a tile line that discharges to a water of the state. On September 19, 2008, DNR Field Office 6 observed that the earthen manure storage structure had no freeboard and that the manure was flowing over the top of the structure to the road ditch located along Elm Avenue. On September 26, 2008 and October 2, 2008 manure solids and liquids were observed on the ground between the earthen manure storage structure and

September 19, 2008. Picture shows the discharge from the Earthen Manure Storage Structure as well as the weeds and poor vegetation.

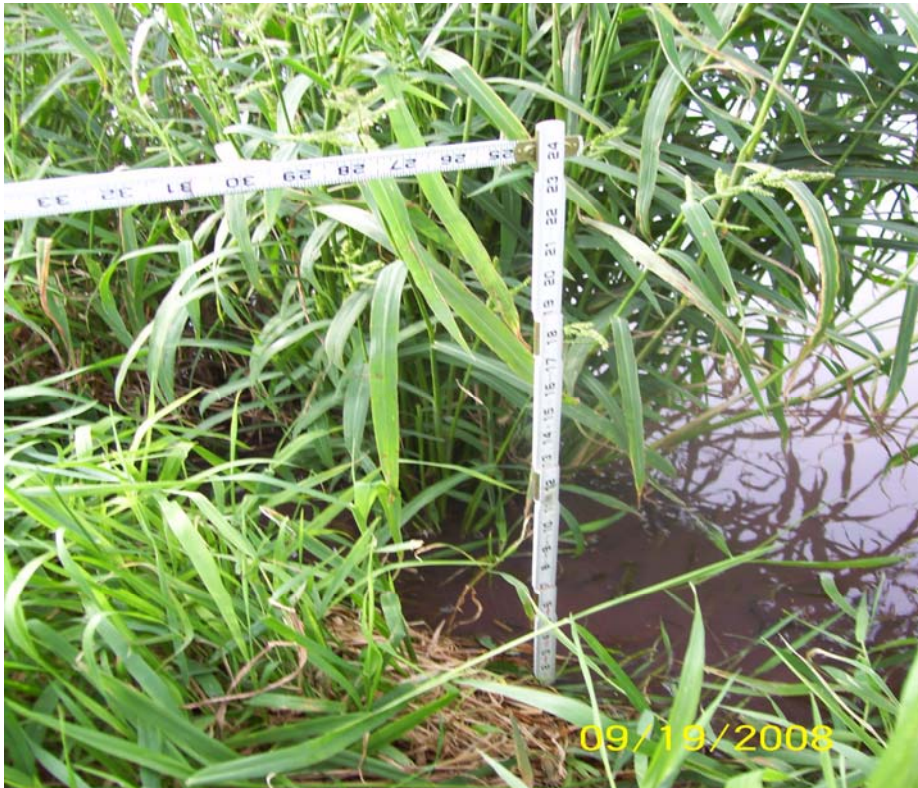
567 IAC 65.2(3)"b" states that manure shall be removed from the control facilities as necessary to prevent overflow or discharge of manure from the facilities. Manure stored in unformed manure storage structures or earthen waste slurry storage basins shall be removed from the structures as necessary to maintain a minimum of two feet of freeboard in the structure. On September 19, 2008, DNR Field Office 6 observed that the earthen manure storage structure had no freeboard and that manure was discharging over the top of the structure to the road ditch located along Elm Avenue. Follow-up visits by DNR Field Office 6 on September 23, September 26, October 2, October 7, and October 15 indicated that the freeboard did not meet the minimum requirement of two feet. As of October 15, 2008, the earthen manure storage structure had been out of compliance with the freeboard requirement for at least 27 days.

September 19, 2008. Picture shows inadequate freeboard for the Earthen Manure Storage Structure.

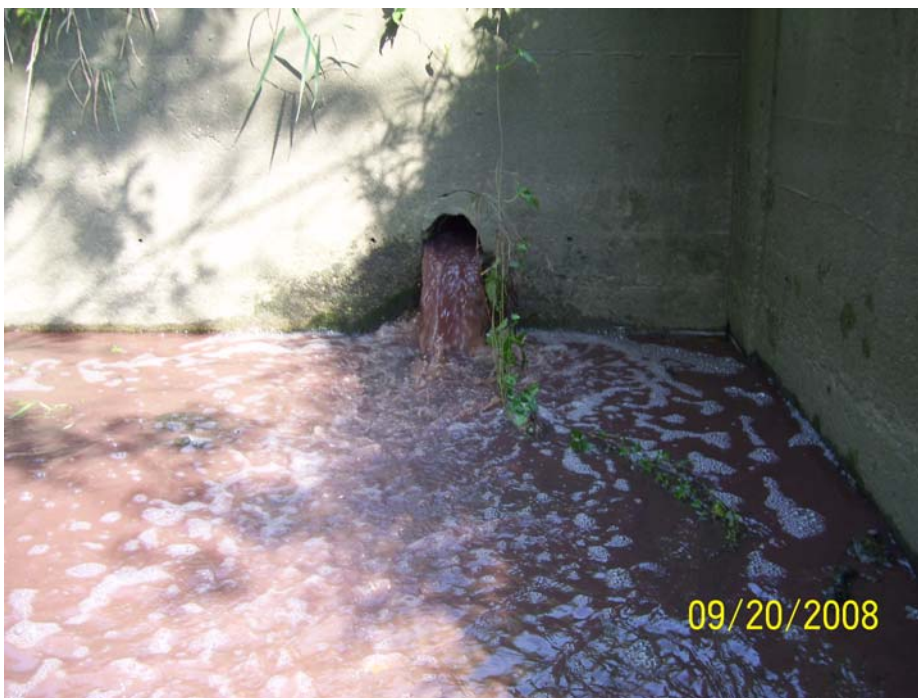
567 IAC 65.2(7) states that all manure removed from an animal feeding operation or its manure control facilities shall be land-applied in a manner which will not cause surface or groundwater pollution. On September 20, 2008, DNR Field Office 6 noted runoff from the land application of manure by spray irrigation entered a field tile that discharged into a ditch to the West Fork of Crooked Creek. The field office confirmed that the manure had reached the creek. The above mentioned facts indicate a violation of this provision.

September 20, 2008. Tile discharge observed by DNR Field Office 6. Discharge was caused by 76 Ltd. manure application. Ammonia – 80 mg/L; BOD – 98 mg/L; TSS – 220 mg/L; Fecal Coliform – 480,000/100mL.

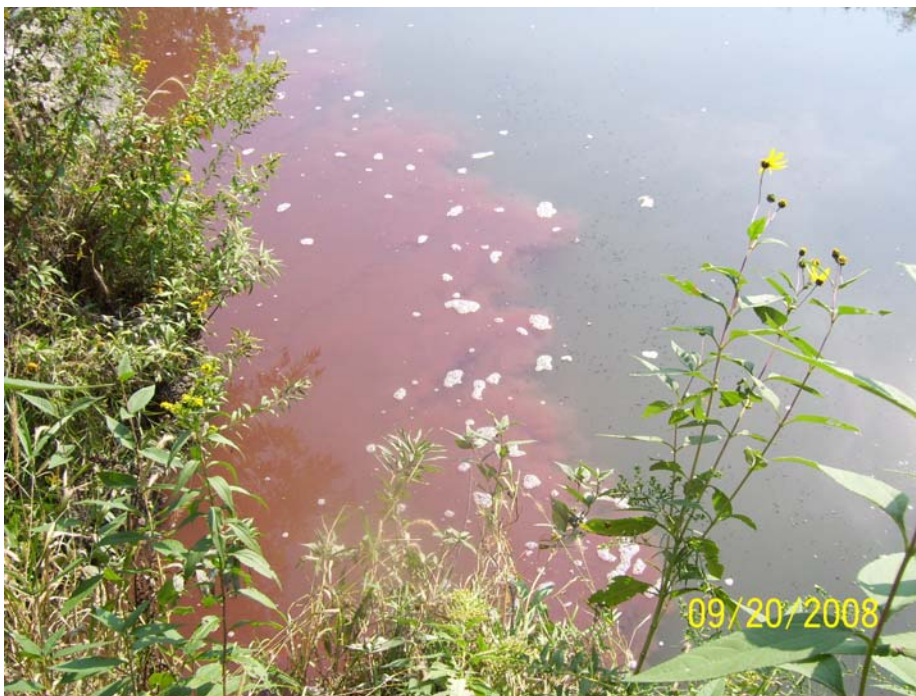
567 IAC 61.3(2) provides general water quality criteria and prohibits discharges that will produce objectionable color, odor or other aesthetically objectionable conditions; settle to form sludge deposits; interfere with livestock watering; or are toxic to animal or plant life. On September 20, 2008, DNR Field Office 6 observed discoloration and sludge in the West Fork of Crooked Creek from the manure discharge caused by 76 Ltd.'s irrigation system. Additionally, laboratory results indicated elevated levels of Ammonia, BOD, TSS, Fecal Coliform, and E. Coli in the West Fork of Crooked Creek due to the manure discharge. The above mentioned facts indicate several violations of the general water quality criteria.

September 20, 2008. Slug of discolored water in the West Fork of Crooked Creek near the confluence from the discharge.

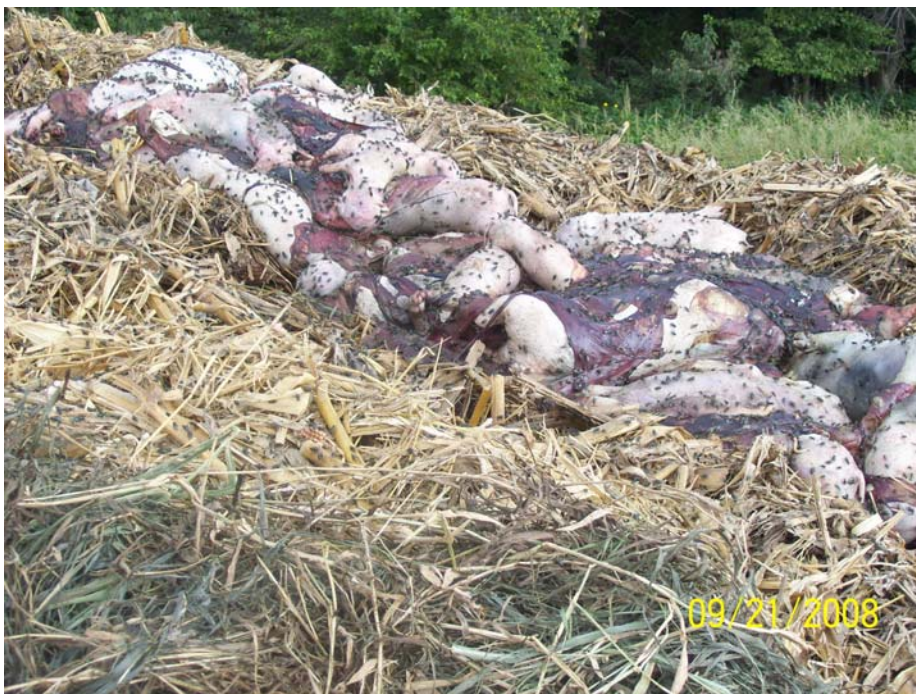
567 IAC 105.6(6) states that dead farm animals shall be incorporated into the composting process within 24 hours of death. An adequate base layer with 6 to 12 inches of bulking agent between carcasses and an additional 12 inches of cover material shall be maintained around carcasses at all times. On September 21, 2008, DNR Field Office 6 observed a compost pile that had dead animals on top of the piles and covered with flies. Skeletal remains were observed around the pile and were not completely covered. There was evidence of leachate running off toward a grassy area. A follow-up visit on October 7, 2008 indicated that the carcasses of two small pigs were lying next to the pile and skeletal remains could still be observed. The above mentioned facts indicate violations of this provision.

September 21, 2008. DNR Field Office 6 observed dead hogs on the compost pile at 76 Ltd.

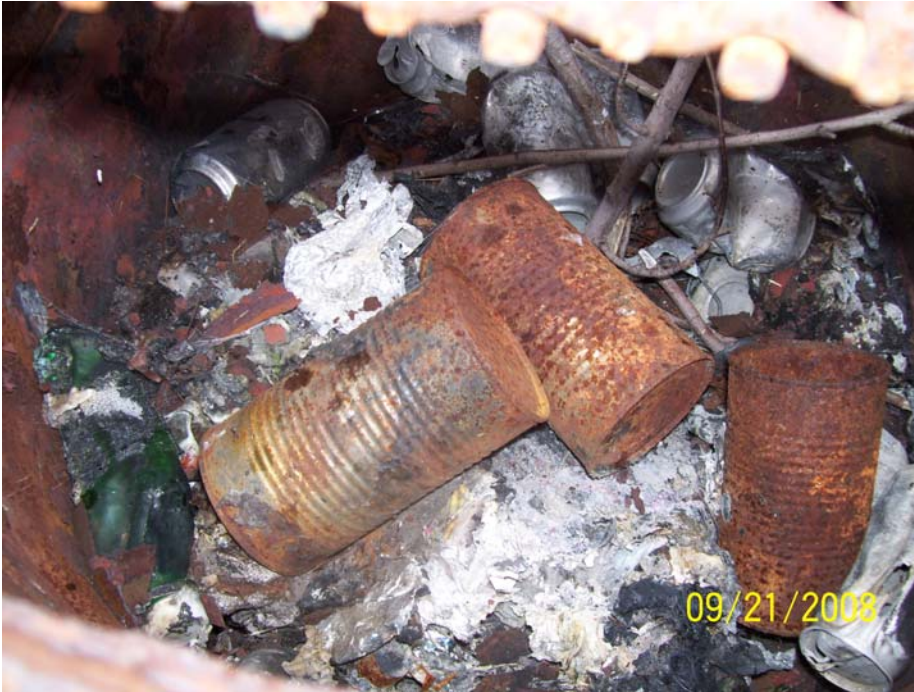
567 IAC 23.2(1) prohibits any person from allowing, causing, or permitting open burning of combustible materials, except as provided in 23.2(2) (variances) and 23.2(3) (exemptions). Over the course of the visits to 76 Ltd. DNR Field Office 6 observed several burn barrels around the facility indicating that trade waste from the facility was being improperly disposed of and burned. The above mentioned facts indicate violations of this provision.

567 IAC 100.4 prohibits a private or public agency from dumping or depositing or allowing the dumping or depositing of any solid waste at any place other than a sanitary disposal project approved by the director. Over the course of the visits to 76 Ltd. DNR Field Office 6 observed several burn barrels around the facility indicating that trade waste

September 21, 2008. DNR Field Office 6 found evidence of improper solid waste disposal and improper open burning at the 76 Ltd. facility.

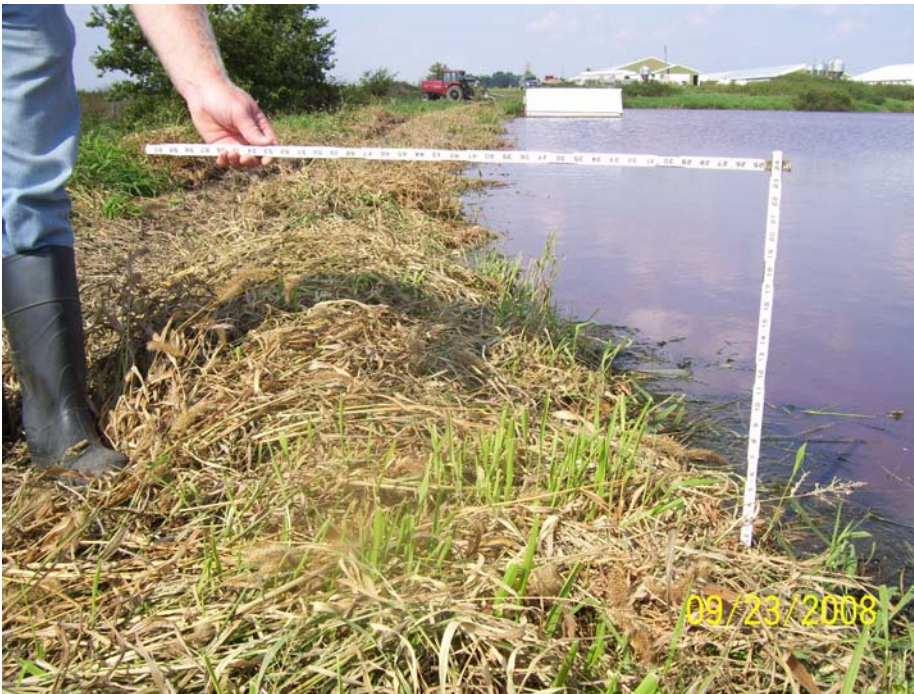
September 23, 2008. Picture shows continued inadequate freeboard.

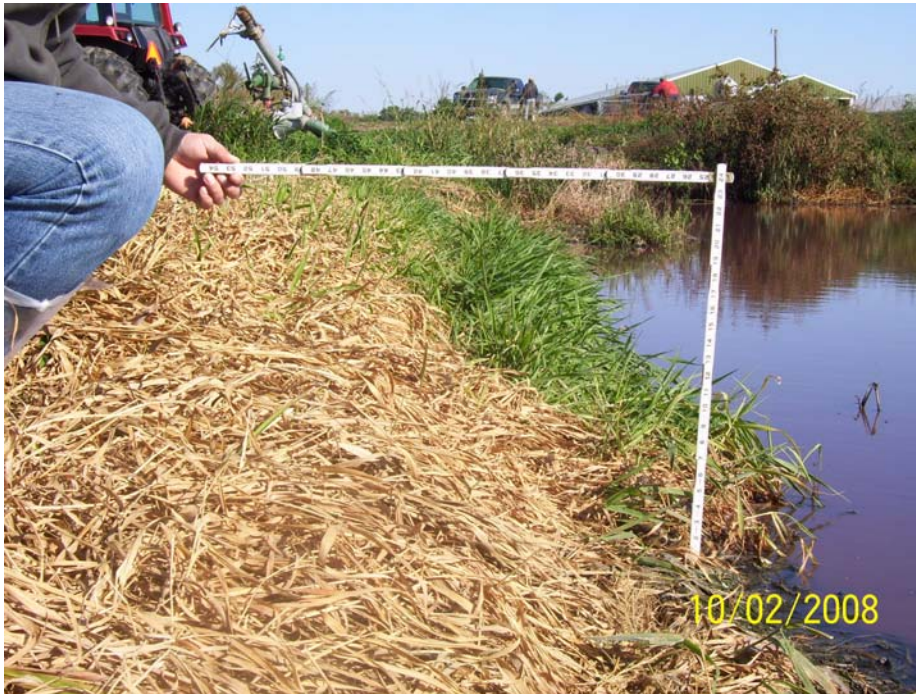
October 2, 2008. Picture shows continued inadequate freeboard.

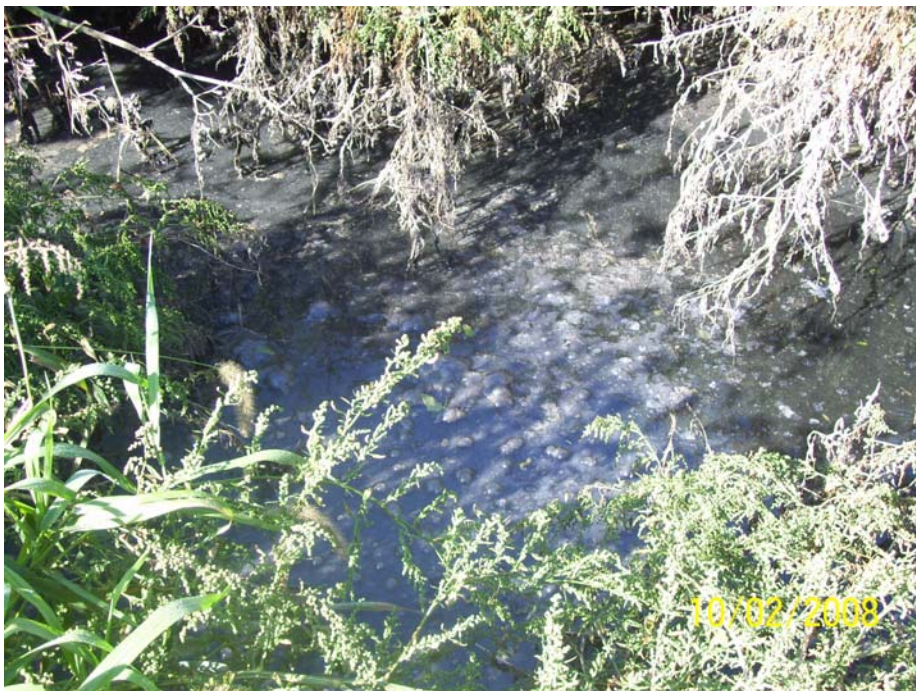
October 2, 2008. Manure liquids and solids on the ground between the buildings and the earthen manure storage structure.
